Case history | New elbows fix pneumatic conveying lines

A water reclamation plant switched the elbow joints in its pneumatic conveying lines to prevent messy, dangerous blowouts.

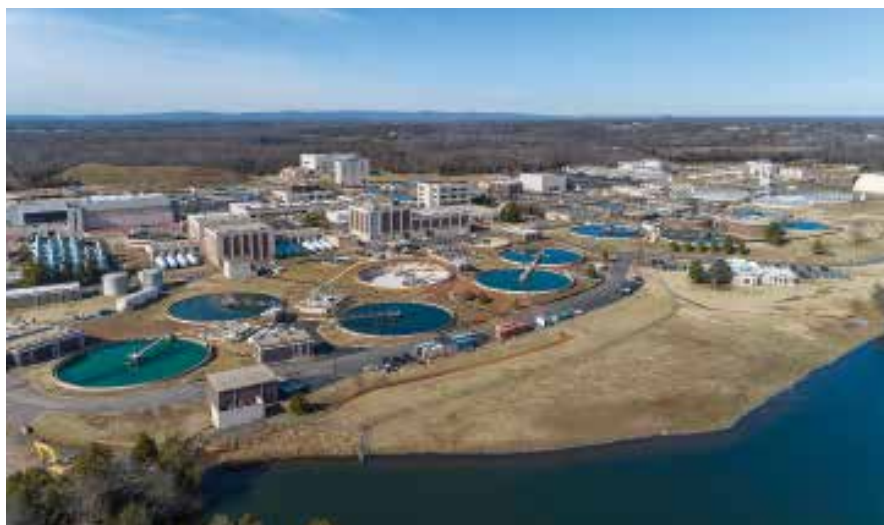
Due to high conveying velocities and the pebble lime's 3 to 4 percent grit content, the pneumatic conveying line's elbow walls experienced frequent failures. During a failure, the plant's workers needed to clean up pebble lime spillage and dust that escaped from a failed elbow. Even a small hole in an elbow would spray abrasive powder into the building, presenting a slip-and-fall risk and threatening indoor air

The Upper Occoquan Water Reclamation Plant supplies more than 30 million gallons of potable water per day. The water treatment process requires the use of pebble lime, a highly abrasive material, to raise the water's pH level.

The proprietary elbow has a spherical chamber that protrudes slightly beyond the desired 90- or 45-degree flow path, causing a loose ball of material to rotate slowly in the same direction as the airstream that propels it, gently deflecting incoming material around the bend. Self-renewing, the ball gradually releases material in a first-in first-out progression, promoting directional change without affecting system pressure.

Forgione tested the deflection elbow for more than a year and, after finding no signs of wear, replaced all pebble lime elbows at the facility. Five 45-degree, 4-inch-diameter elbows were installed where the trucks off-loaded their lime and 12 90-degree, 4-inch-diameter elbows were installed at the tops of the silos. A custom alloy for the elbows was specified based on characteristics of the pebble lime and the length and velocity of the pneumatic conveying system.

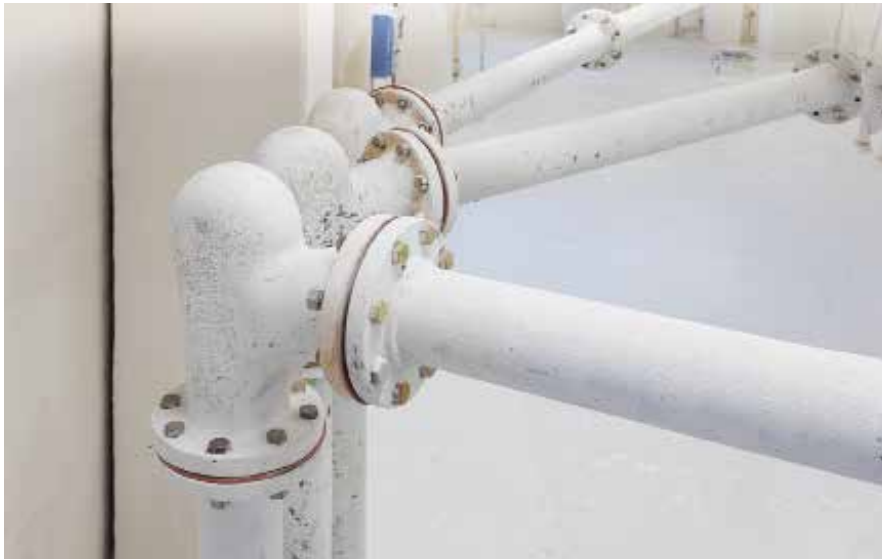
The plant has gone 16 years without an elbow failure after installing short radius deflection elbows on its pneumatic conveying lines.

In more than 16 years since the installation of the deflection elbows, UOSA's facilities have yet to have a blowout. Maintenance and labor costs have been reduced, safety and air quality have been upgraded, and the buildings are visibly cleaner.
